# Correlation of Structural Analysis and Test Results for the McDonnell Douglas Stitched/RFI All-Composite Wing Stub Box

July 1996

National Aeronautics and  
Space Administration  
Langley Research Center  
Hampton, Virginia 23681-0001

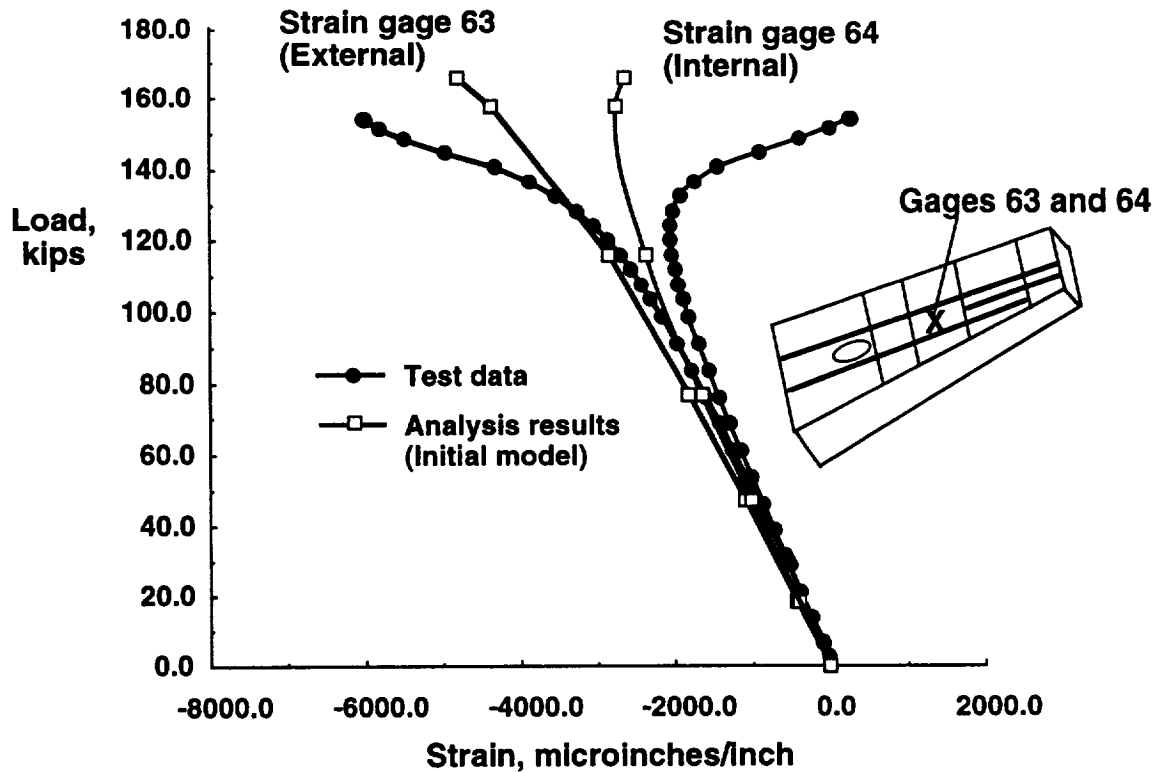
However, during testing, back-to-back strain gages in the center of that region, strain gages 63 and 64 in figure 6, recorded significantly higher strains than predicted by the nonlinear analysis when the applied load exceeded 130 kips, as shown in figure 11. This discrepancy indicates that the initial model could not predict the nonlinear deformation and high strains in the large bay region. Also, the initial model shown in figure 6 has four elements across the skin bay, which may be insufficient to represent the nonlinear behavior of the stub box.

Figure 11. Comparison of strain results from test and initial analysis for strain gages 63 and 64.

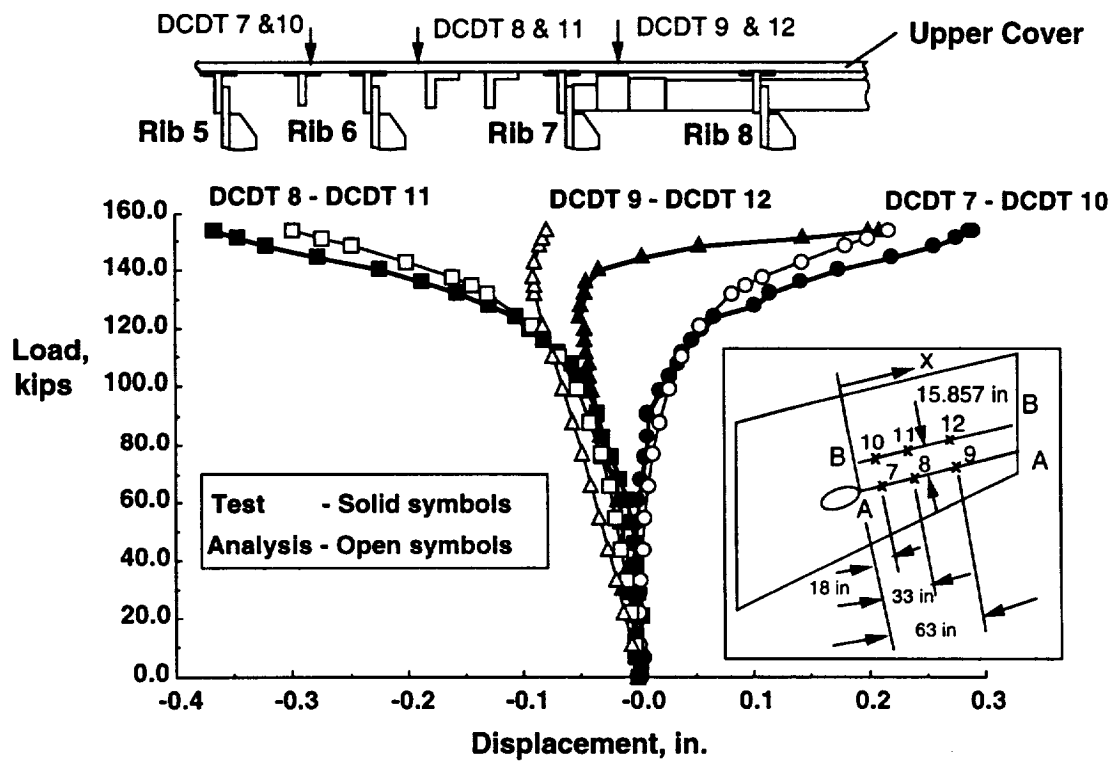
developing in the wide bays outboard of the access door. The analytical and experimental results of the relative out-of-plane displacements (e.g., displacement at DCDT 11 subtracted from displacement at DCDT 8) are shown in figure 16.

The experimental and analytical results correlate well for the locations 18 and 33 inches from the access-door cutout. However, the agreement between experimental and analytical results is not acceptable for the location 63 inches from the access-door cutout. An explanation of this discrepancy is presented in a subsequent section about failure.

Figure 16. Relative out-of-plane displacements for DCDTs on the upper cover panel.

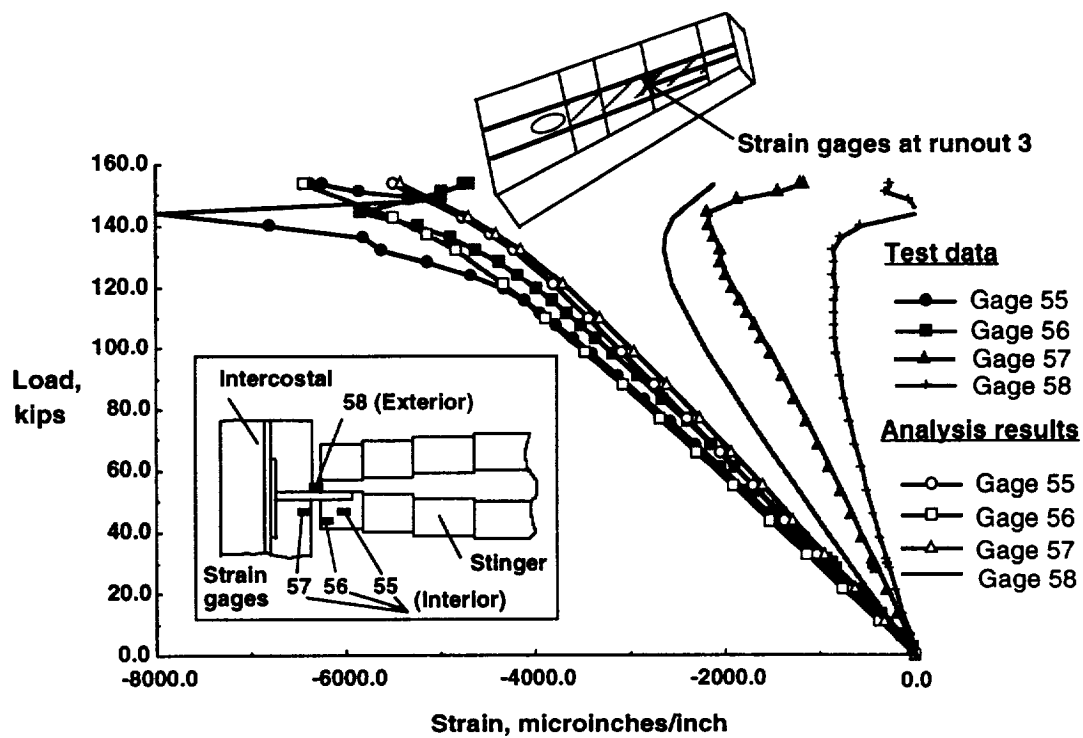
Strain results for internal strain gages 55, 56 and 57 and external strain gage 58 near stringer Runout 3 are shown in figure 31. Strain gages 55 and 56 are located on the stringer flange. Good agreement can be seen between the analytical and experimental results for the stringer-flange strain gages for loads less than approximately 130 kips. The erratic strains recorded at loads above 130 kips by strain gages 55 and 56 indicate that a local failure has just occurred at this load level. The analysis predicts significantly more strain than was recorded by strain gage 57 on the intercostal flange, and by strain gage 58 on the external surface of the skin. The correct trend is predicted on the external surface, including the nonlinear behavior. However, for loads below 130 kips, the strain recorded by gage 57 on the intercostal flange is linear, but it is much less than the predicted strain. The discrepancy between analytical and experimental strain results from gage 57 may be attributed to that this gage was placed right next to edge of a intercostal flange (see insert in figure 31), and the discontinuity of thickness may cause the inaccurate strain predication at this location.

Figure 31. Correlation of strains for strain gages 55, 56, 57, and 58 at stringer runout 3.

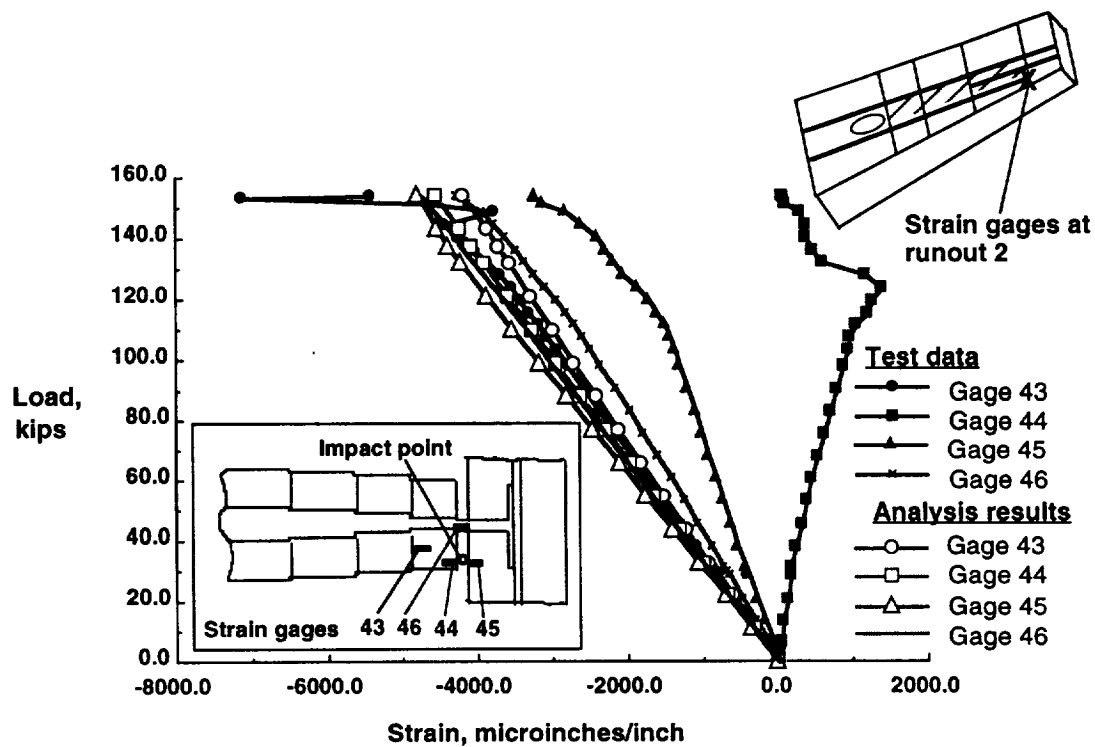
Strain results for gages 43 through 46 on the upper cover panel in the stringer Runout 2 region are shown in figure 32. Poor correlation for strain gages 44 and 45 is very likely due to this location being subjected to a 100 ft-lb impact damage to the external skin prior to the final test. Strain gages 44 and 45 are located on interior flanges less then 0.4 inches from the impact site. The data recorded for these two strain gages from this final test are not the same as in previous

tests (as described in reference 3 for these previous tests involving no impact damage at stringer Runout 2). Since the analysis does not consider damage in this region, correlation between the final test results and analytical results should not be expected for strain gages 44 and 45. Strain gages 43 and 46 are approximately one inch from the impact site, where little damage would be expected. For loads below 120 kips, linear behavior is observed for strain gage 43, which is mounted on the flange of the runout stringer, and the experimental and analytical data correlate well. At higher loads, some nonlinear behavior is observed in the experimental results and significant discontinuities in the data can be seen at loads of approximately 140 kips and 145 kips, indicating local failures and load redistribution. However, no such discontinuities can be seen in the external strain gage, gage 46. Further discussion of this apparent interior local failure is presented in a subsequent section on failures.

Figure 32. Correlation of strains for strain gages 43 through 46 at stringer runout 2.

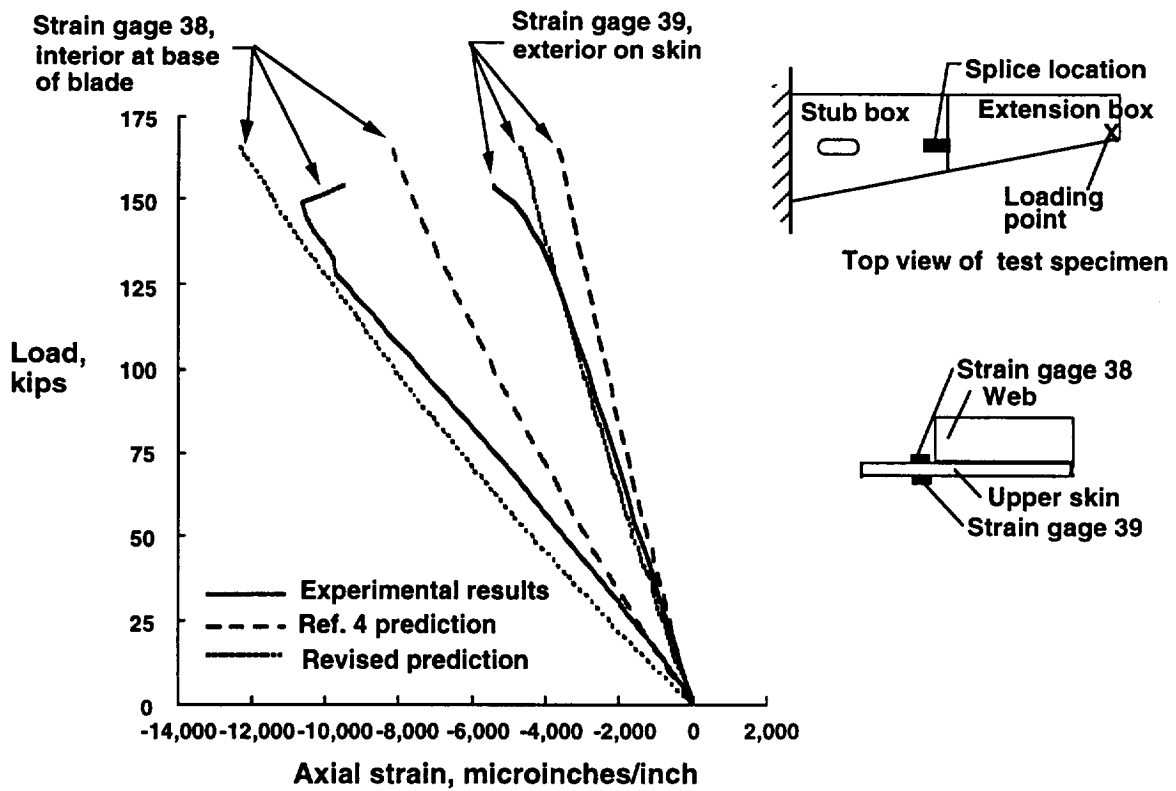
Experimental data and analytical results for strain gages 38 and 39 are shown in figure 33. For loads less than 130 kips, the results from the refined analysis agree well with the test data and are approximately linear. This same strain was recorded during each of the four tests of the stub box. The sudden change in the slope of the load-strain curve of the test data at approximately 130 kips can be attributed to local failures elsewhere in the stub box since no failure was detected at this splice.

Figure 33. Correlation of strains for strain gages 38 and 39 at the splice joint.

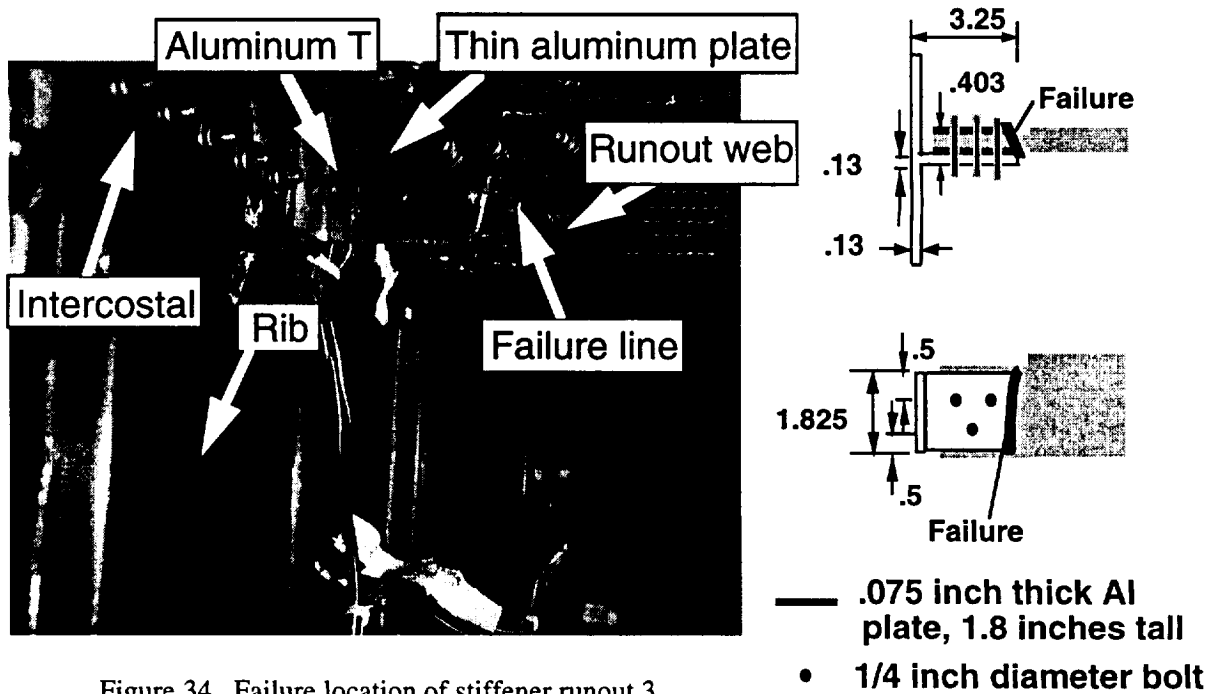
Test results indicate that catastrophic failure of the stub box occurred when the upper-cover-panel skin failed through the impact site at stringer Runout 2. Post-test evaluation of the test article revealed local failures in both stringer Runouts 2 and 3 (see figure 8 for locations). These failures occurred in the thinnest portion of the web and flange of the stringer runout. The failure at stringer Runout 3 is shown in figure 34. While the stringer separated from the skin, no skin failure is evident at stringer Runout 3. Displacement and strain gage data at stringer Runout 3 indicate that an initial failure may have occurred at a load of approximately 135 kips as evidenced by discontinuities in the readings of strain gage 55 which is on the stringer runout flange, as shown in figure 31. However, no measured axial strain in this region is greater than the allowable strain. Shear strain in the stringer runout web was not measured experimentally, but analytical results indicate the presence of high shear strains in the thinnest portion of the stringer runout web, at the failure location. A contour plot of the shear strain at the failure load in the stringer runout web is shown in figure 35. The analytical results indicate that the shear strain alone would have been enough to induce failure prior to the maximum load of 154 kips applied to the test article.

Figure 34. Failure location of stiffener runout 3.

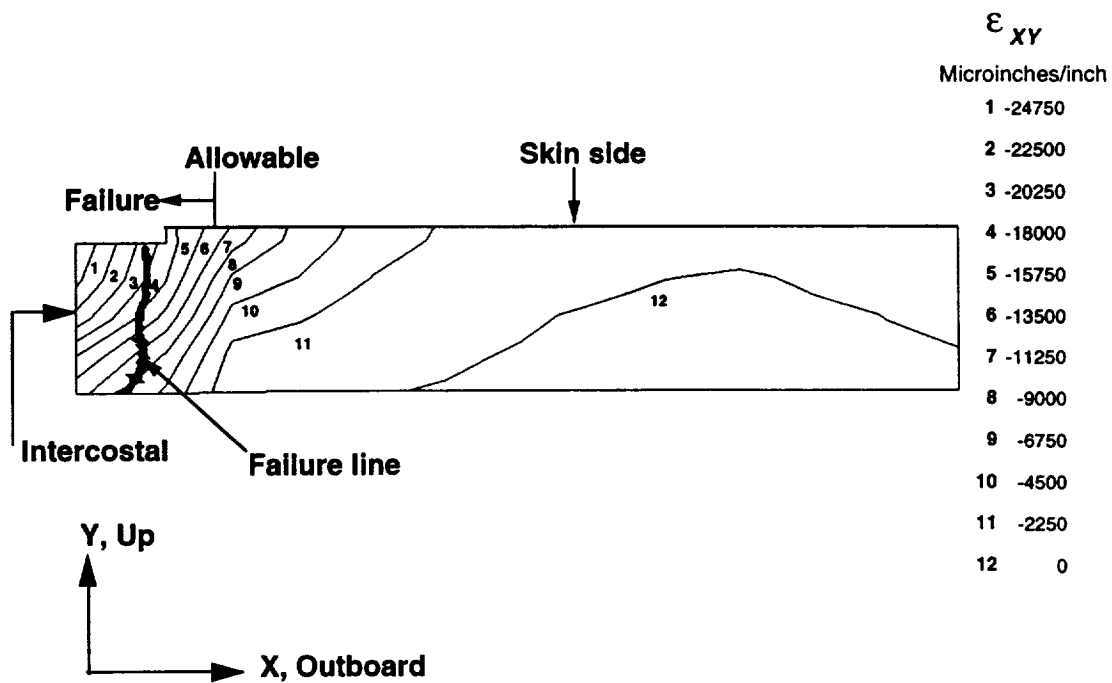
The behavior of stringer Runout 2 is similar to the behavior of stringer Runout 3. The present model, which does not account for the reduction of stiffness in the impact damage zone near stringer Runout 2, predicted that the maximum shear strain at the failure load in the stringer web at stringer Runout 2 is 0.01069 which is about 15% below the shear allowable. However, when other factors, such as the axial strain in the stringer web and the increase of stringer web load due to the reduction of load carrying capability of the impact damage zone, are taken into consideration, failure of the stringer web at the stringer Runout 2 is likely. Indeed, the discontinuity of strain results from strain gage 43 indicate that a local failure occurred at 140 to 145 kips (see figure 32). An analysis that assumed the stiffener web at stringer Runout 2 had failed predicted an increase in the skin axial stress resultant of about 3.6% in the stringer runout region. The catastrophic failure of the box involving the skin failure at stringer Runout 2 occurred at a load of 154 kips, thereby implying that the stringer runout web failure did not immediately propagate into the skin. The test of an intermediate wing box, which has the same stringer runout design as the stringer runouts in the stub box, resulted in the same failure mode, as described in reference 10. A video camera inside the intermediate wing box confirmed this analytically-based failure scenario. It recorded the failure progression at that stringer runout and the failure of the thin web and flange occurring well before the failure of the skin. Strain gage

Figure 35. Shear strain contour plot for stringer runout 3 at the failure load.
